# Town of Arlington

## FINAL REPORT

### ADA Self-Evaluation (as basis for Transition Plan)

Prepared by  
Institute for Human Centered Design  
December 15, 2014

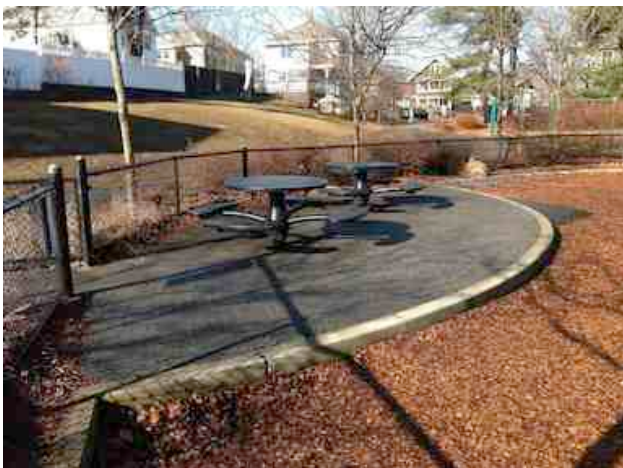
Photo 6

There are two gated entry points to the playground and sitting area (Photo 6) and, there is a gate to the Teel Street Basketball court entry point.

Gates are missing smooth surface or kickplate hardware. Teel St. gate to the basketball courts is not along an accessible route and ground surface is not firm, level and smooth.

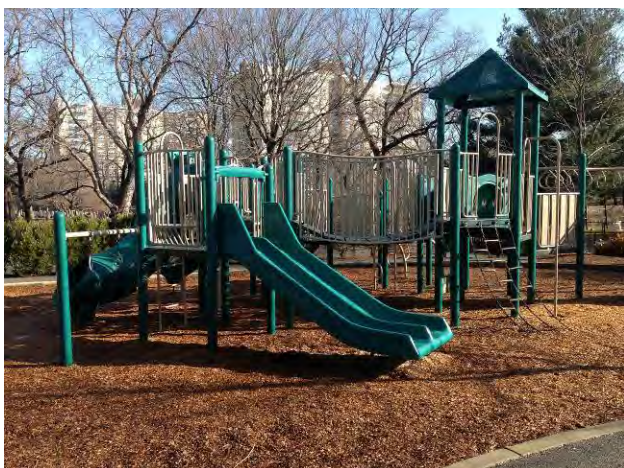
Photo 9

At least one accessible route is not provided within site perimeter to all entry/exit points of play areas, including court, swingsets and playground; and there is no accessible route provided to all entry/exit points of the ground play structures and elements within the play areas. (Photo 9)

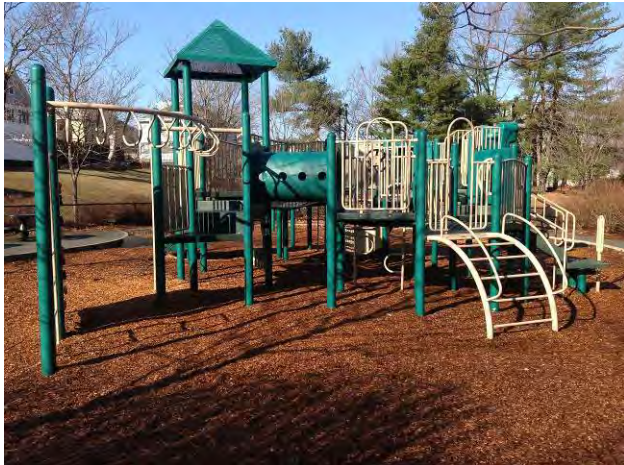
Photo 10

The smaller play zone has two stationary swing sets with 4 swings. The larger playground has free-standing swing rockers, a stationary swing set with 2 bucket swings; and a composite play structure with at least 7 ground play elements and at least 14 elevated play components.

The composite play structure has an excellent variety of accessible ground play elements plus a transfer system that provides access to various types of elevated play elements, including interactive panels, climbing, crawling and swinging play elements. (Photo 10)

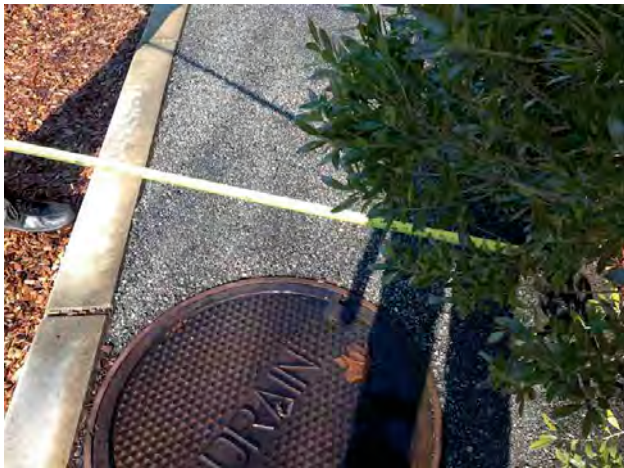
Photo 11

The walkway around the perimeter of the playground area narrows to less than 36 inches wide in places. The grate cover in photo obstructs passage to a bench. (Photo 11)

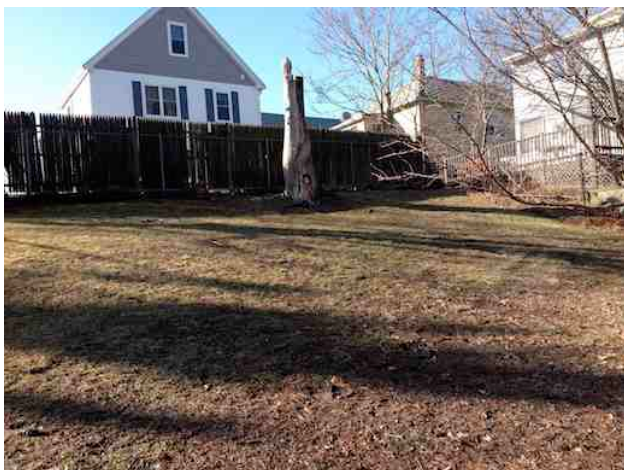
Photo 12

A public art tree sculpture sits on the west hill near the Waldo Road entrance. This art installation has the potential to be a special meeting and socializing area within this Park. If possible, a level-graded path with at least 36 inches width along the west perimeter of the park can be installed for all to approach and enjoy this unique feature. This path can connect with the Teel St. entryway. (Photo 12)

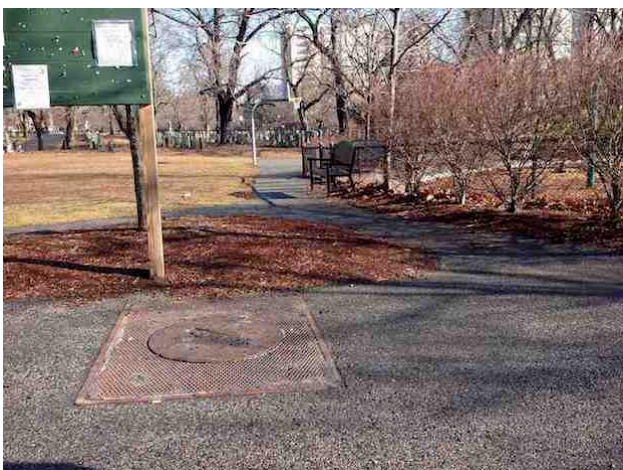
Photo 15

The Bulletin board lacks clear ground space for approach because it is located near a utility cover. (Photo 15)

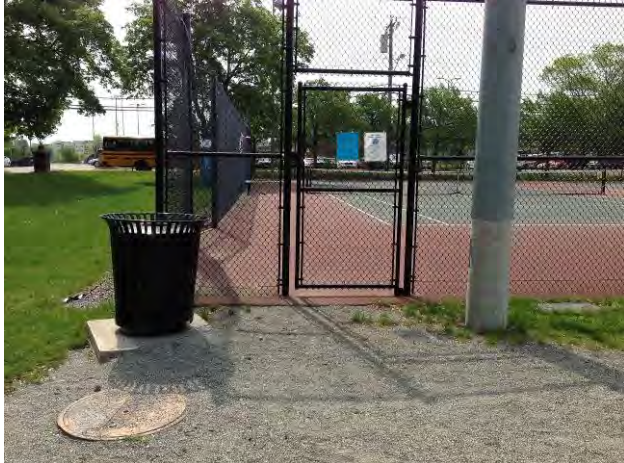
Photo 4

There are two gated entry points to each tennis courts. All gates are missing smooth surface or kickplate hardware. The surface of the two gates adjacent to the gravel walkway on the north edge of the courts is not firm, level and smooth. (Photo 4)

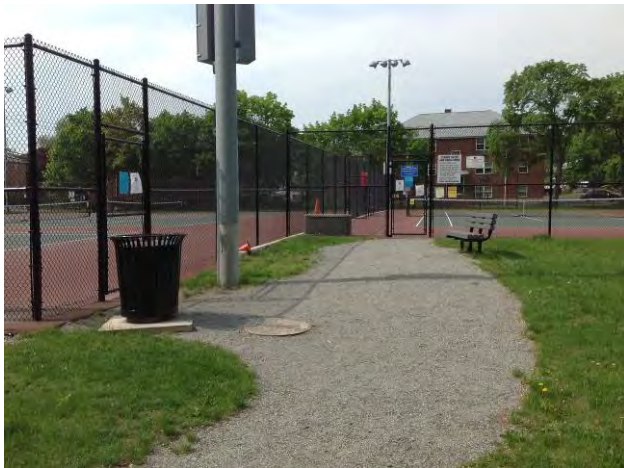
Photo 5

A gravel walkway is provided between the point of entry at the northeast point of the site and the north edge of the tennis courts. Walking surface is not consistently firm, stable or slip-resistant near the tennis courts. (Photo 5)

Repair/compact gravel walkway or replace it with asphalt walkway near the tennis courts (about 50 feet) and extend asphalt walkway from the tennis courts to climbing wall (about 150 feet).

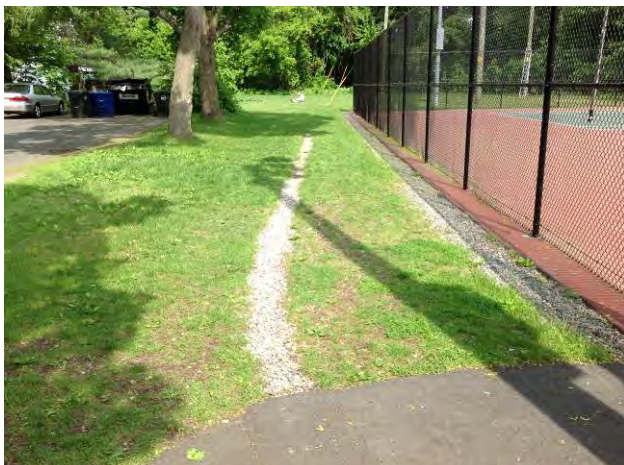
Photo 6

Along the south edge of the tennis courts, an asphalt walkway provides an accessible route between the street and the tennis courts. However, the walkway does not extend beyond the tennis courts and an accessible route is not provided to climbing wall on the west side of the site. (Photo 6)

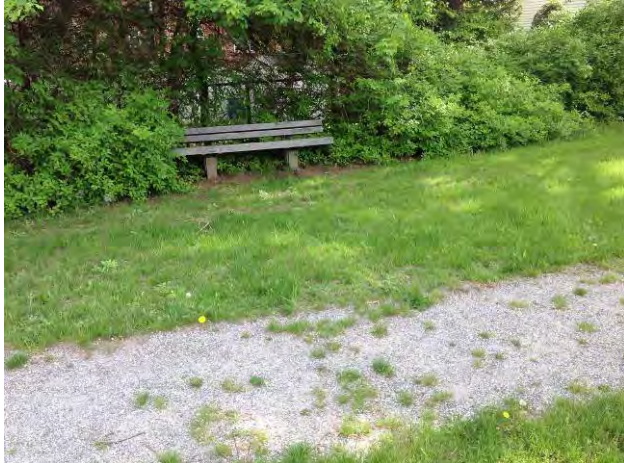
Photo 7

Two benches are provided along the gravel walkway on the north side of the tennis courts. One bench located along the north edge of the site is not inaccessible because it does not adjoin an accessible route. (Photo 7)

Neither bench has armrest nor do they offer integrated shoulder-to-shoulder clear ground space that is firm, level and slip-free for wheelchair seating.

Although not a requirement under the ADA, consider providing at least 50% with armrests, as benches are replaced (total of 2 benches).

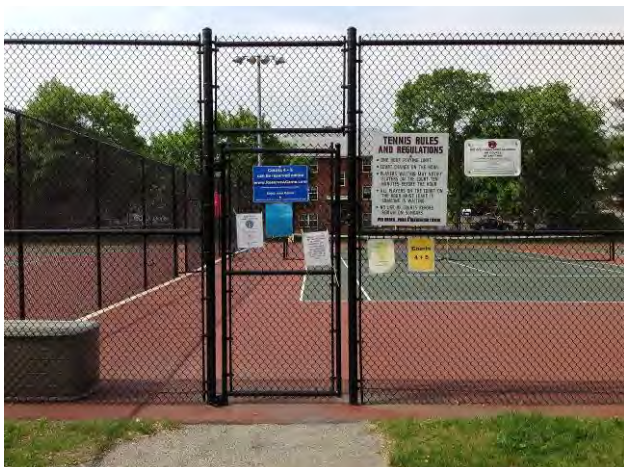
Photo 9

Informational signage is provided at the entrance gate areas. (Photo 9)

Informational signage is not accessible because it is not mounted between 40 and 60 inches from the ground; and, there is not level, firm and clear ground space to approach and read signs. Where signs prohibiting dogs are placed, policy needs to be modified to allow the use of a service dog. Information regarding this exception to the policy should be included where the policy is posted.

Although not a requirement under the ADA, consider creating an ADA-compliant graphic standard and implementing a comprehensive signage plan that is clear and not redundant.

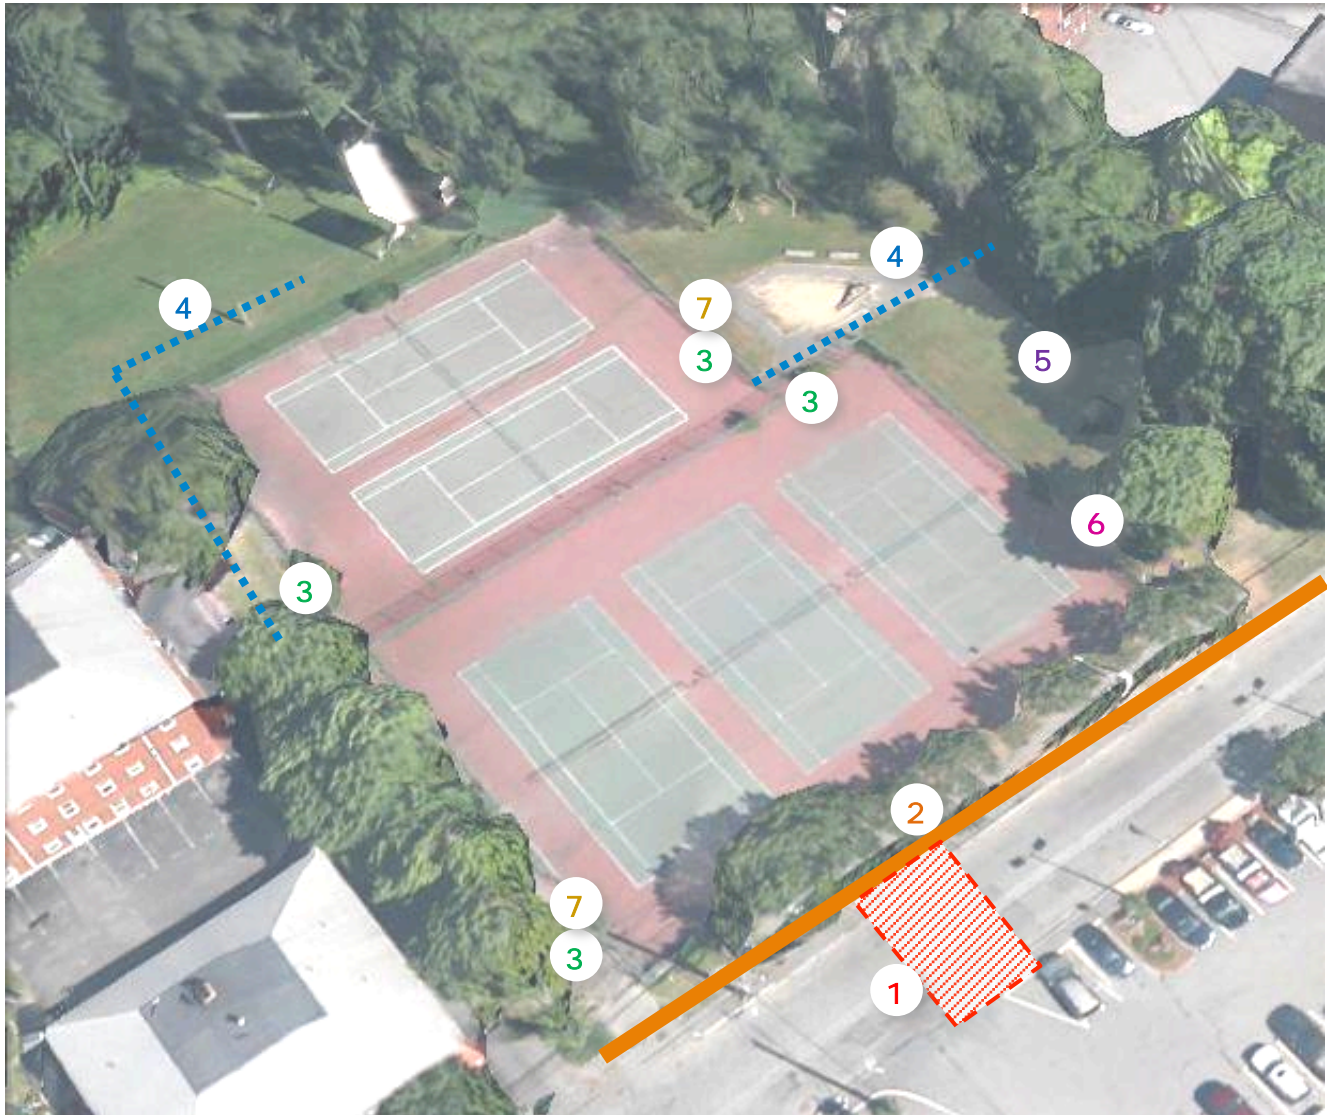
### Wellington Park ADA Recommendations

- 1 Crosswalks and Curb Ramps:** Consider providing a new crosswalk across Grove Street at the intersection of the general path used by the students of the Arlington High School.
- 2 Sidewalks:** Repair sidewalk along Grove Street.
- 3 Points of Entry:** Install compliant hardware and kickplates on each gate to the tennis courts.
- 4 Interior Walkways:** Repair/compact gravel walkway or replace it with asphalt walkway near the tennis courts and extend asphalt walkway from the tennis courts to climbing wall.
- 5 Benches:** Relocate bench to edge of gravel walkway or extend gravel pathway to bench.
- 6 Portable Toilet:** Relocate the portable toilet along the existing walkways or extend the gravel walkway to it.
- 7 Signage:** Consider creating an ADA-compliant graphic standard and implementing a comprehensive signage plan that is clear and not redundant.
